THE NEW ORLEANS HURRICANE PROTECTION SYSTEM: What Went Wrong and Why

**A Report by the American Society of Civil Engineers
Hurricane Katrina External Review Panel**

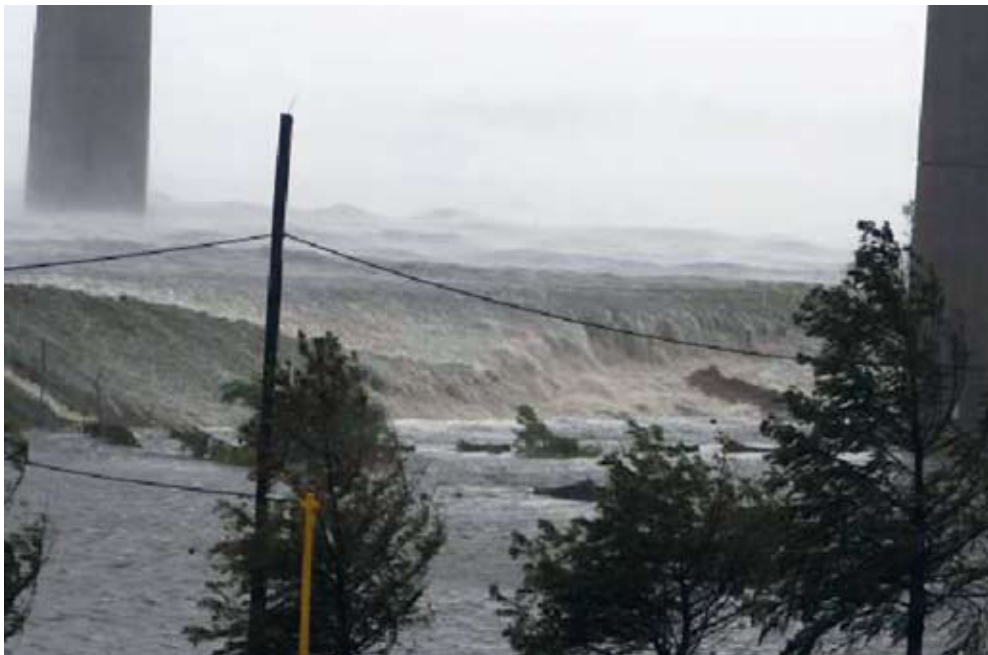
Figure 5.1 Storm Surge under the Paris Road Bridge in New Orleans East

Entergy Corporation personnel took this photo of storm surge waters cascading over a levee near the Entergy power plant in the New Orleans East area.

Even though this earthen levee was overtopped (as was shown in Figure 5.1), it sustained relatively minor damage. (This photo was taken after floodwaters had receded.)

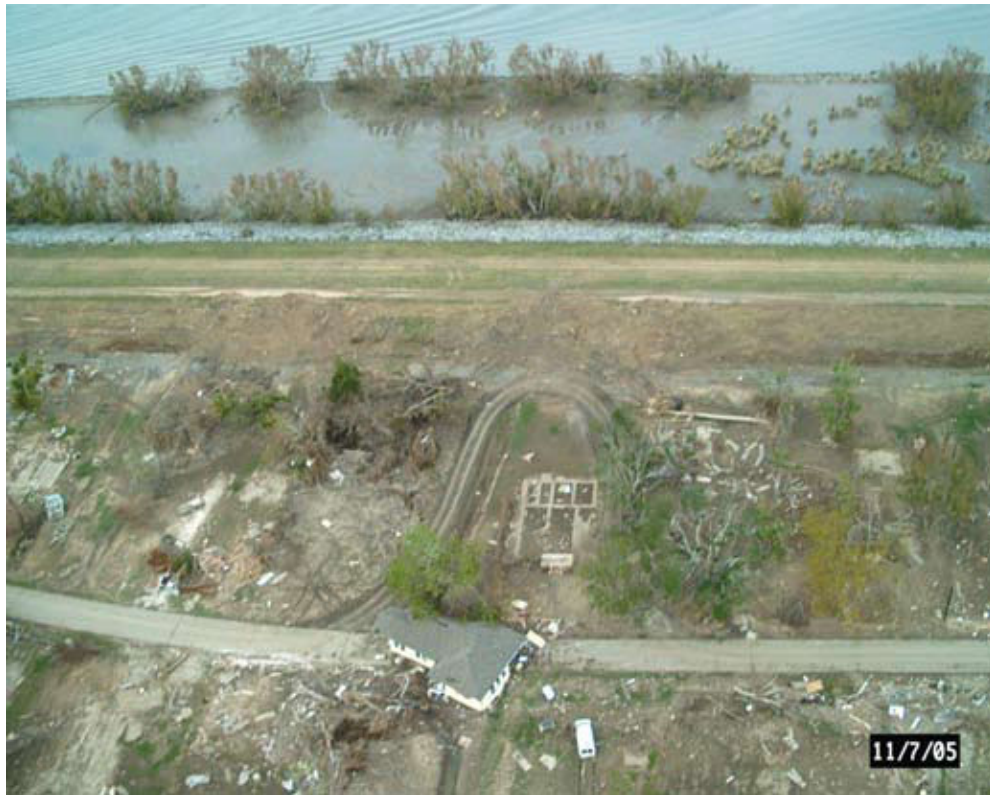
Figure 5.2 Hurricane Damage in Plaquemines Parish

The storm surge from Hurricane Katrina overtopped levees (seen in this photo adjacent to the water) in Plaquemines Parish and knocked hundreds of homes off their foundations. (This photo was taken after flood waters had receded.)

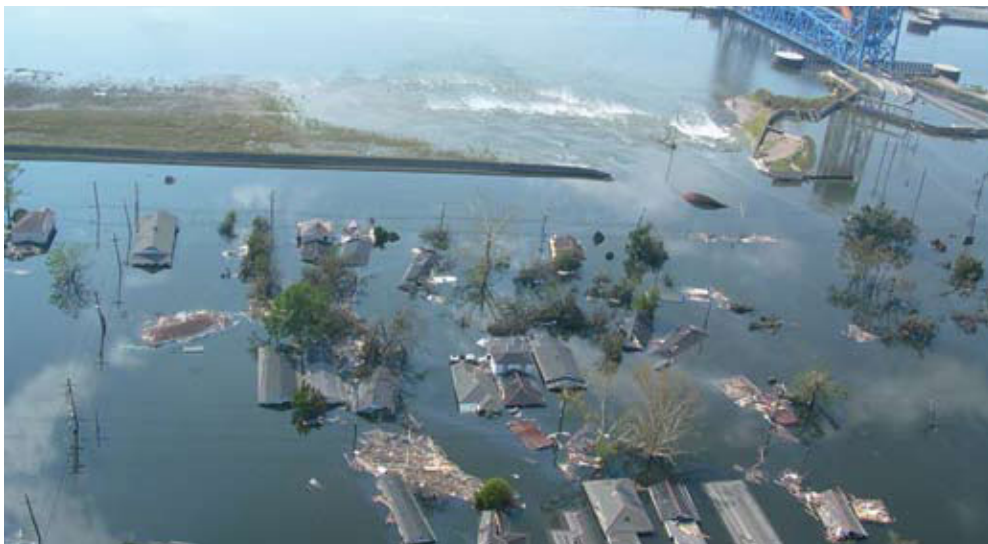
Figure 5.4 Industrial Canal, East Bank, North Breach

Floodwater from the Industrial Canal (top) rushed through a breach in the east bank I-wall into the Lower Ninth Ward (bottom). Water from the Industrial Canal also flowed into the Upper Ninth Ward, Bywater, and Tremé neighborhoods from breaches on the west side of the canal. (This photo was taken after floodwaters began to recede and water flowed from the Lower Ninth Ward back into the Industrial Canal.)

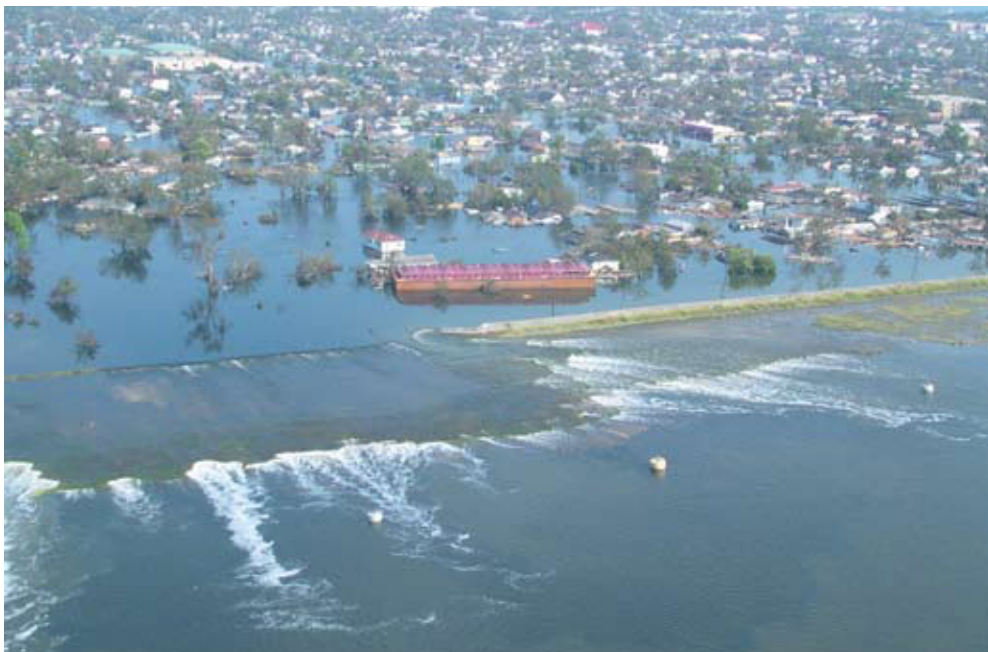
Figure 5.5 Industrial Canal, East Bank, South Breach

Water cascading over the floodwall at this location scoured out the wall's support and caused the breach. Waters from the Industrial Canal (bottom) rushed into the Lower Ninth Ward (top) with great force. (This photo was taken after the floodwaters began to recede and water flowed from the Lower Ninth Ward back into the Industrial Canal.)

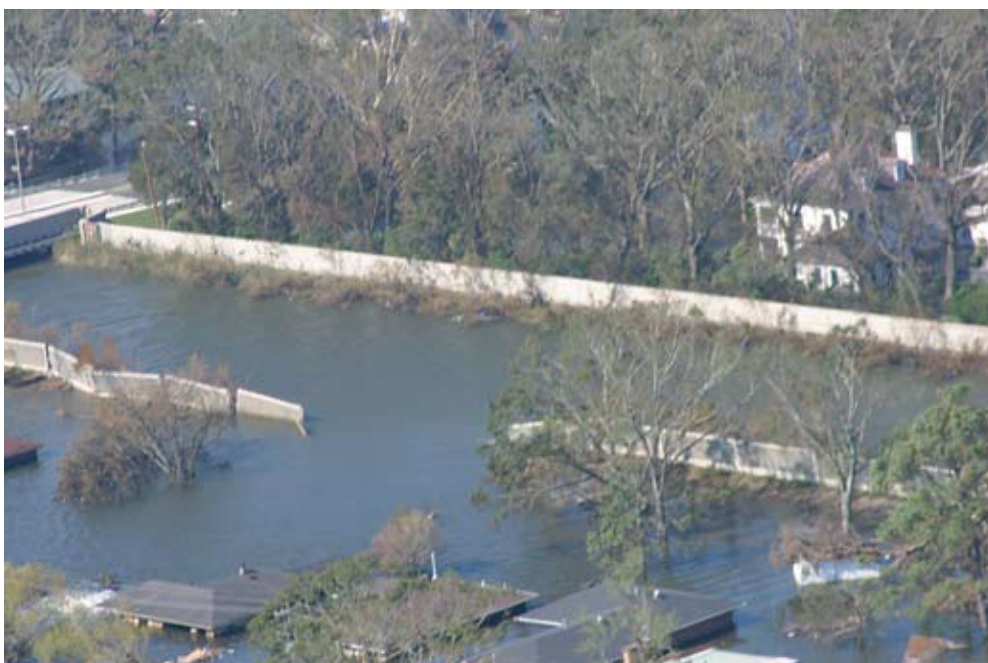
An I-wall failure on the east side of the London Avenue Canal allowed water to spill into the Gentilly neighborhood of New Orleans.

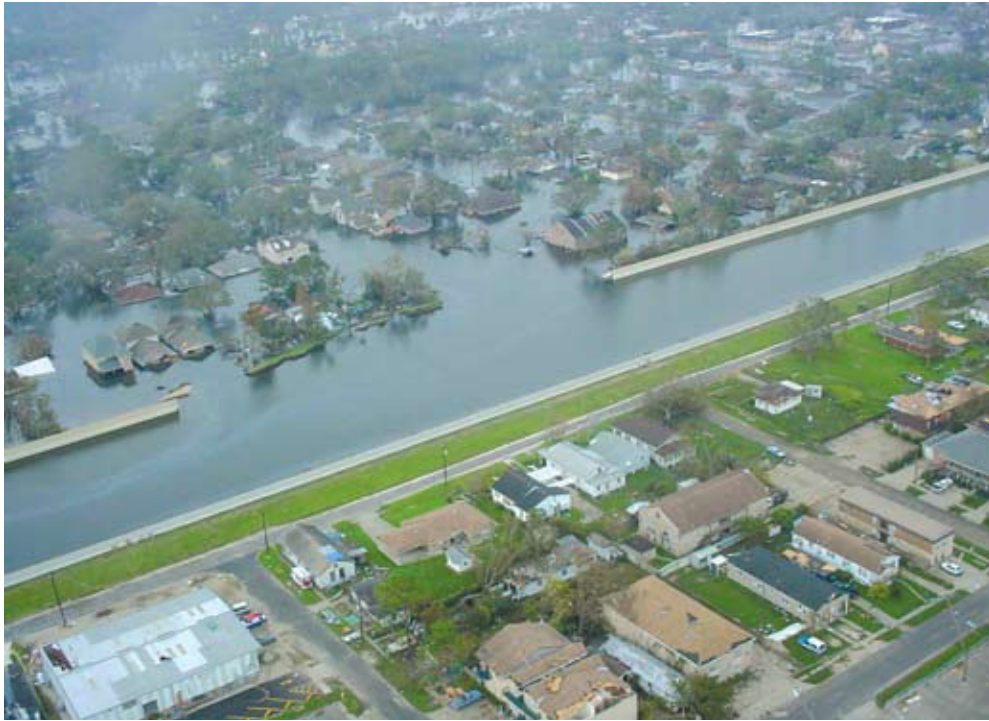
The 17th Street Canal breach began at approximately 6:30am. By 9:00am, torrents of water from Lake Pontchartrain were rushing in to flood the Lakeview neighborhood (top of photo) and, ultimately, much of midtown New Orleans and surrounding areas.

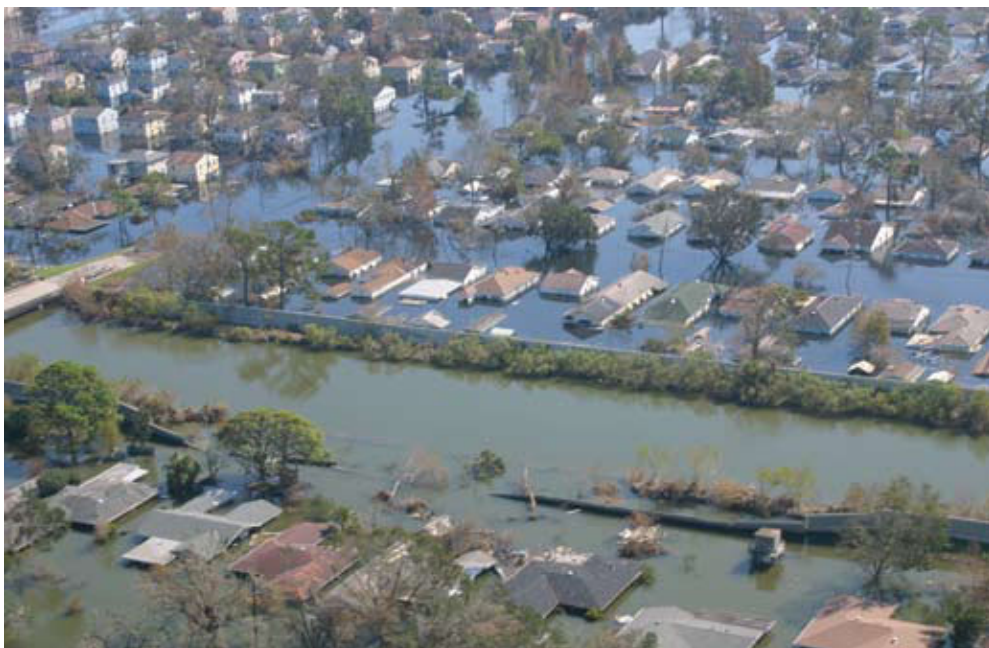
The I-wall along the west side of the London Avenue Canal failed at about 8:00am, allowing water to flood into the City Park neighborhood of New Orleans.

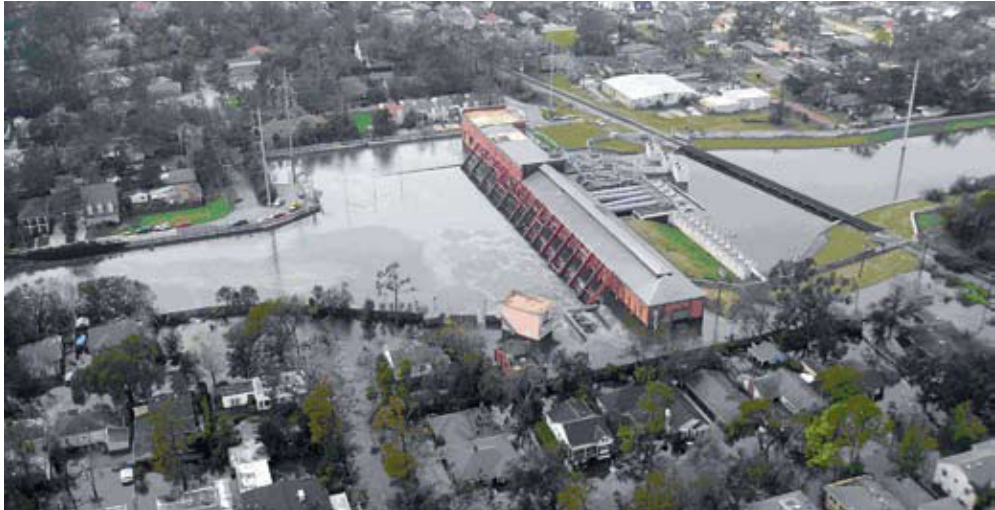
Rapid and far-reaching flooding caused by the hurricane protection system failure left most pump stations, such as Station No. 6 (on the 17th Street Canal), inoperable.

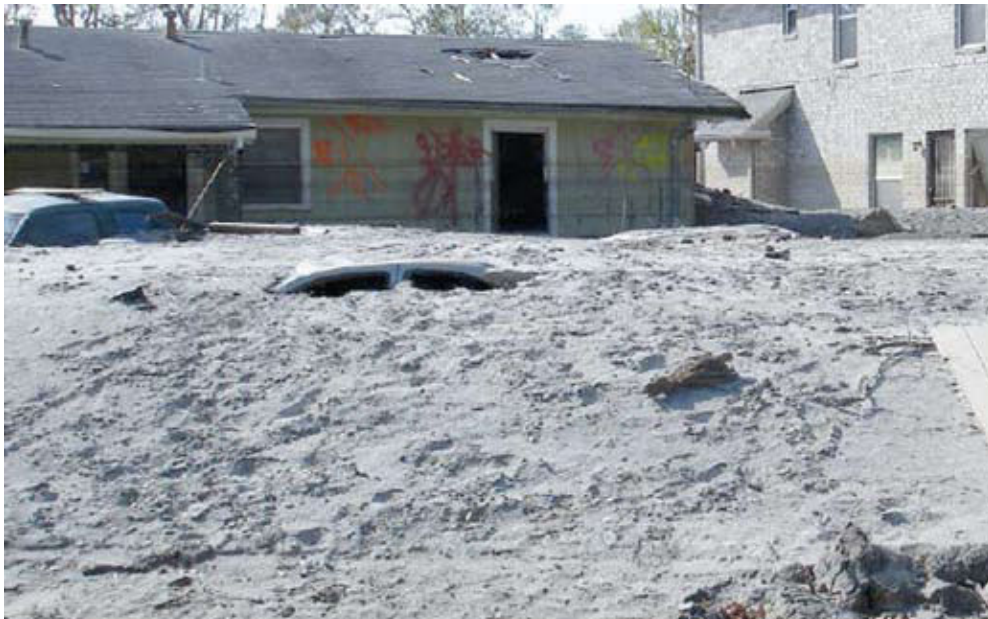
Tons of sand were washed out from beneath the levee and floodwall at the London Avenue Canal South Breach and flowed into the adjacent neighborhood. (This photo was taken after floodwaters had been removed.)

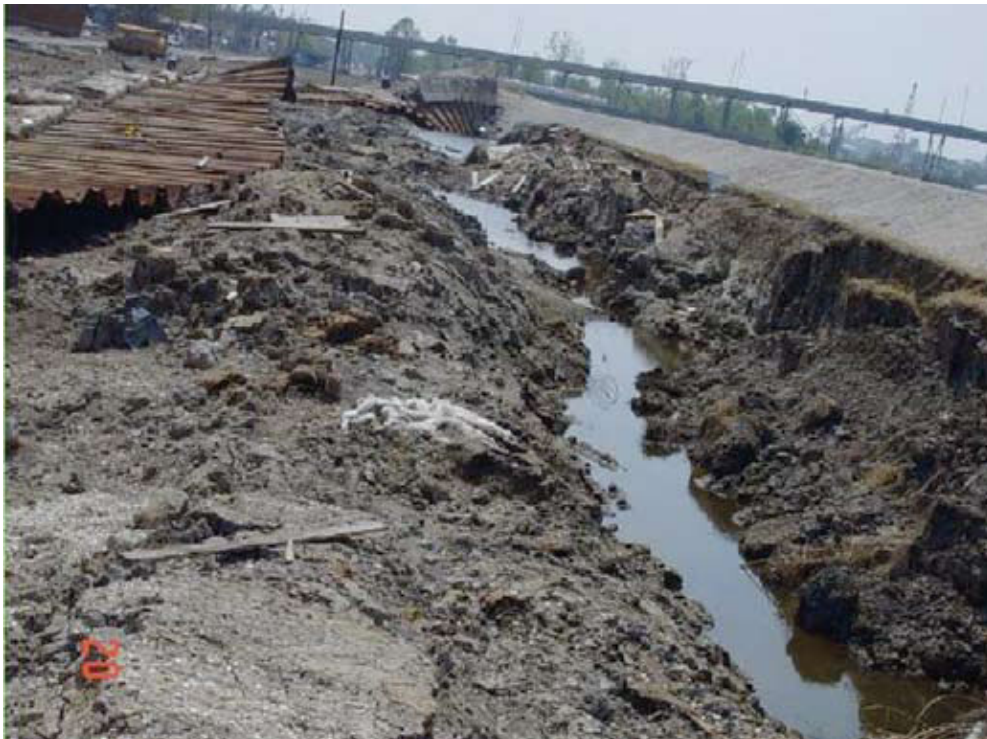
Cascading floodwaters gouged a deep trench on the land-side of the Industrial Canal. Without foundation support from the soil, the sheetpile wall (upper left) was tossed aside. (This photo was taken after floodwaters had been removed.)

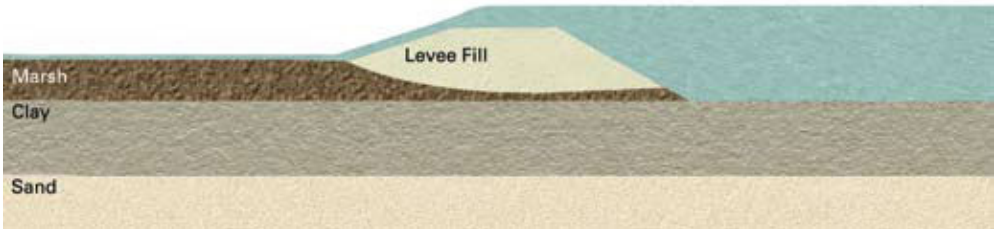
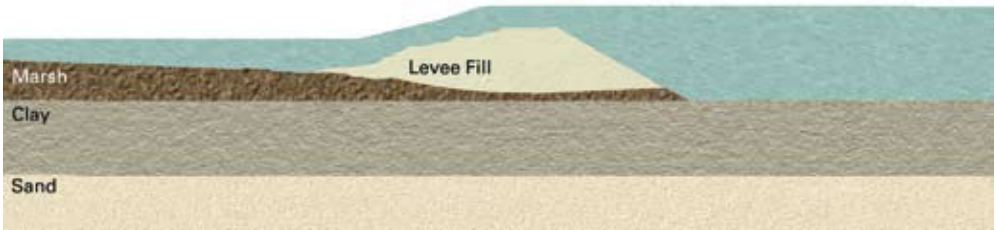
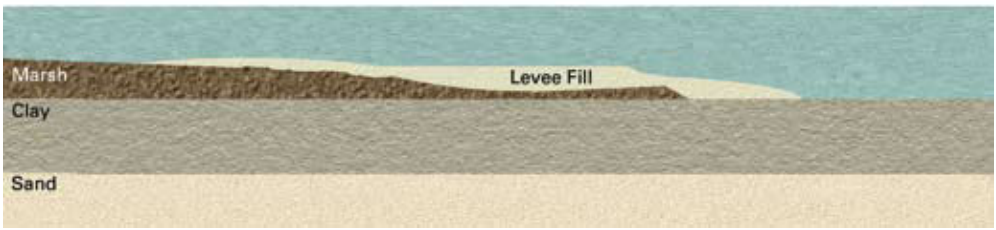
1: Floodwaters overtop the levee.

2: The water scours soil from the crest and land-side of the levee and washes it away.

3: Some levees constructed of sand and silt washed away completely.

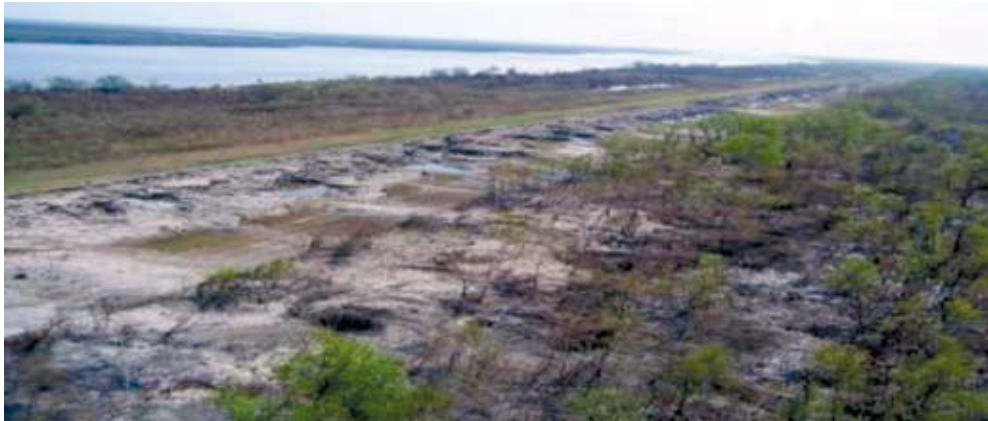
Many levees that were constructed with hydraulic fill severely eroded or washed away entirely. (This photo was taken after floodwaters had receded.)

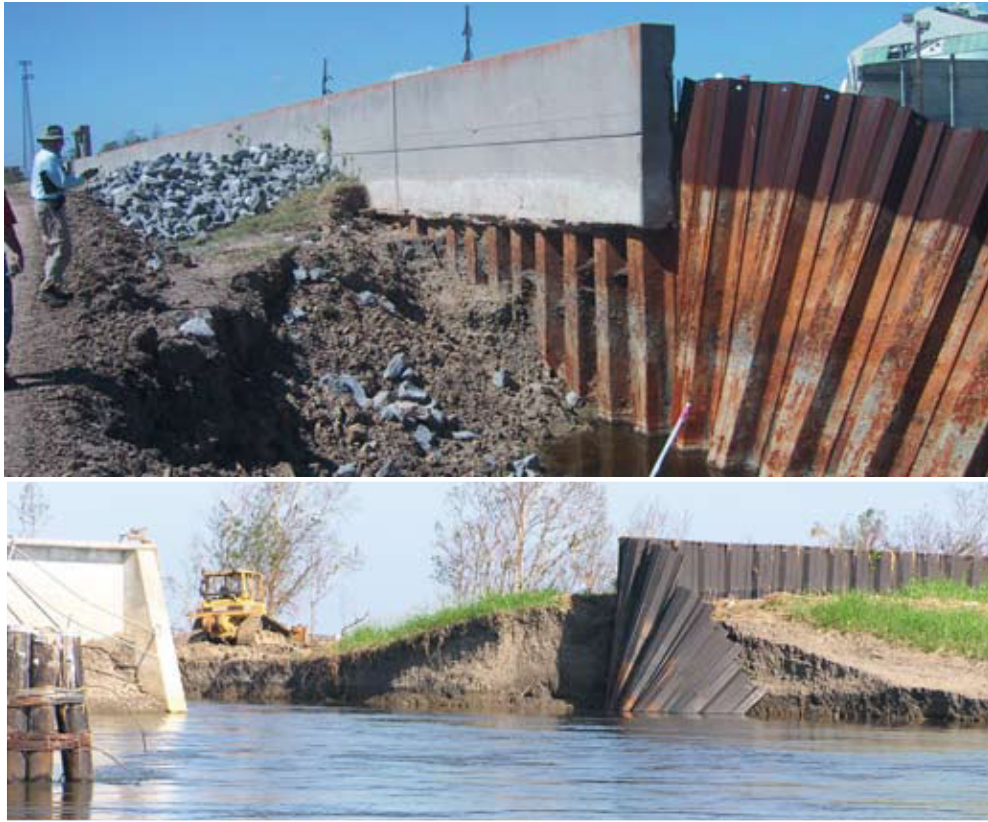
The levees and I-walls were constructed piecemeal with different top elevations and of different materials: earth, steel, and concrete. The floodwaters preferentially attacked the lower-elevation erodible earth first, causing major breaches.
